COMMISSION OF
INQUIRY INTO THE
AIR ONTARIO CRASH
AT DRYDEN, ONTARIO

Final Report

Volume I

The Honourable Virgil P. Moshansky
Commissioner

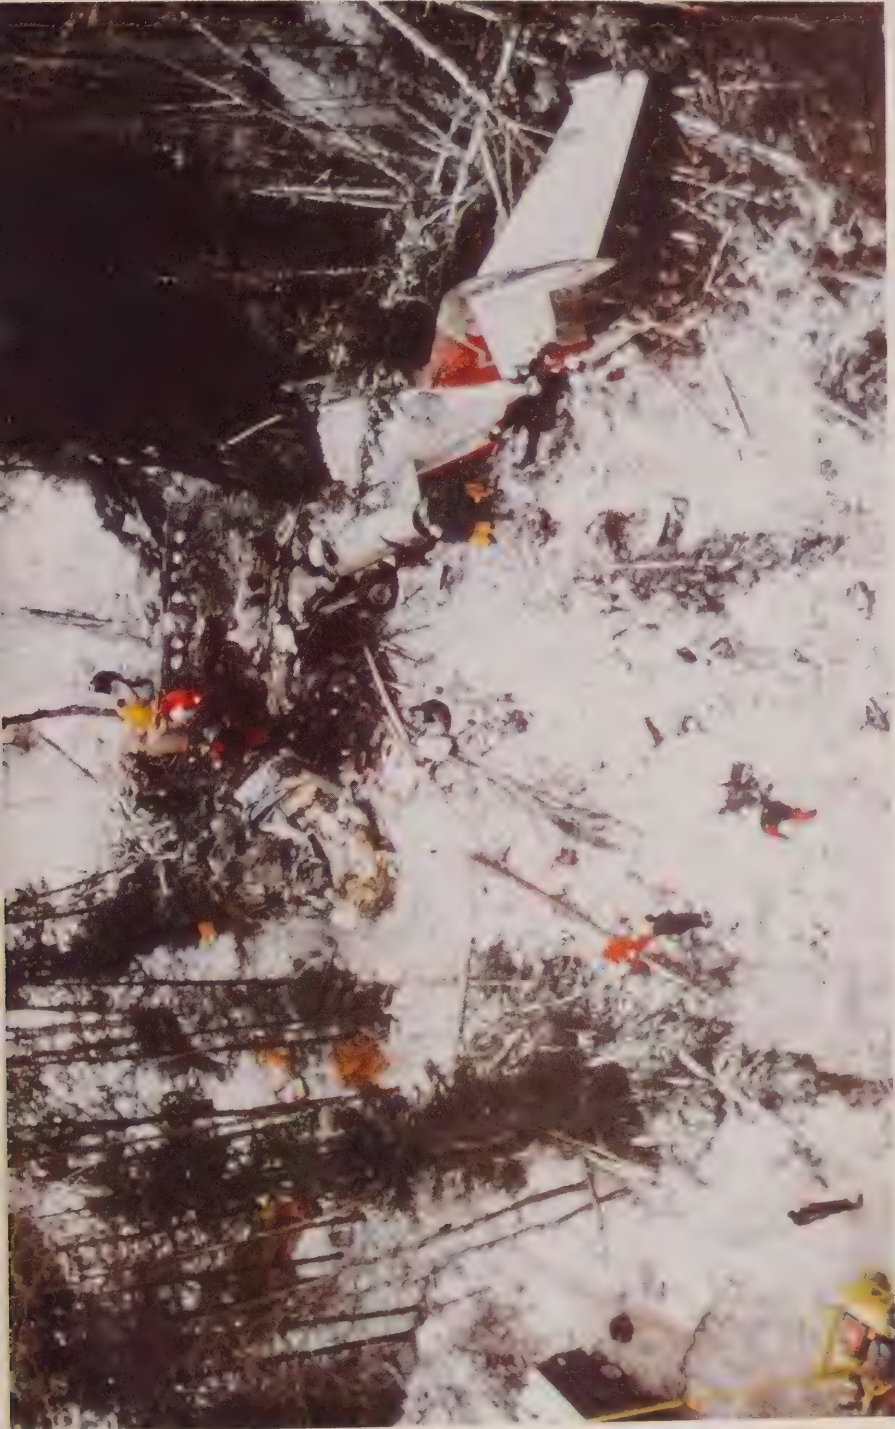
An aerial view of the wreckage of C-FONF, showing the aircraft in three pieces. The Air Ontario designator is clearly visible on the tail section.

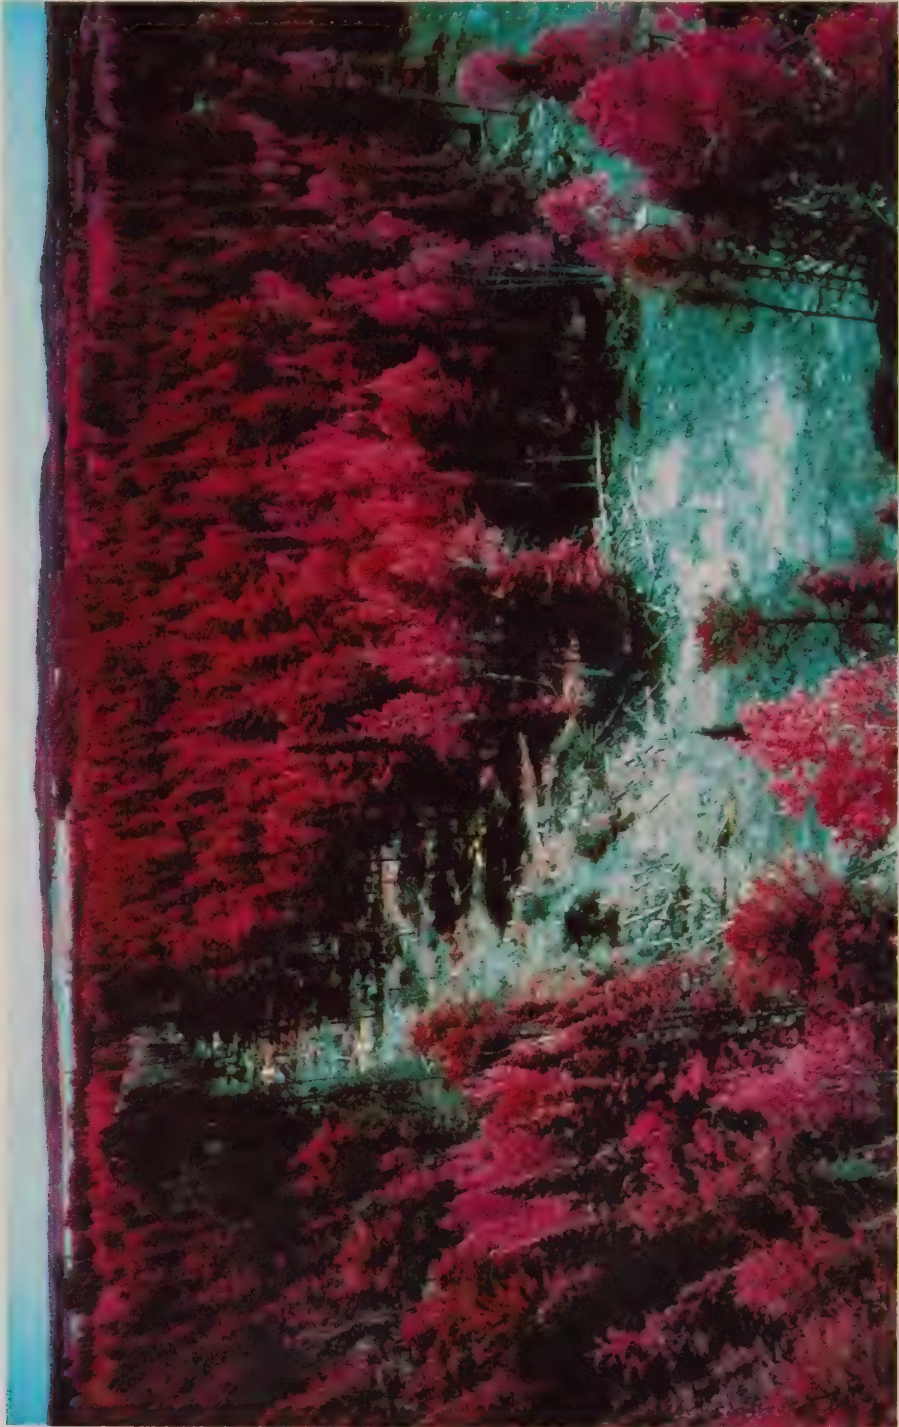
This infrared photograph shows the extent of the fire damage to trees along the flight path.

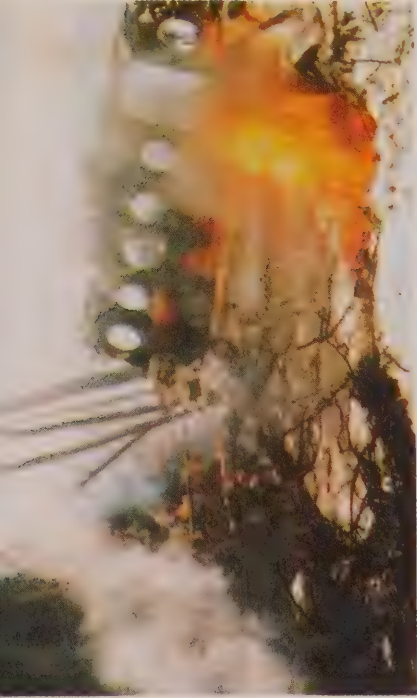
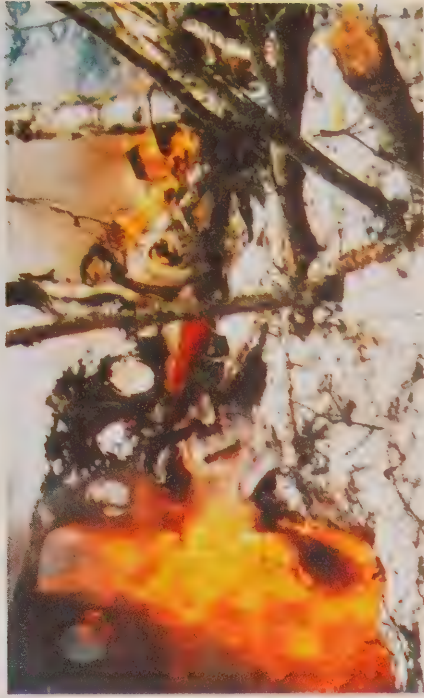
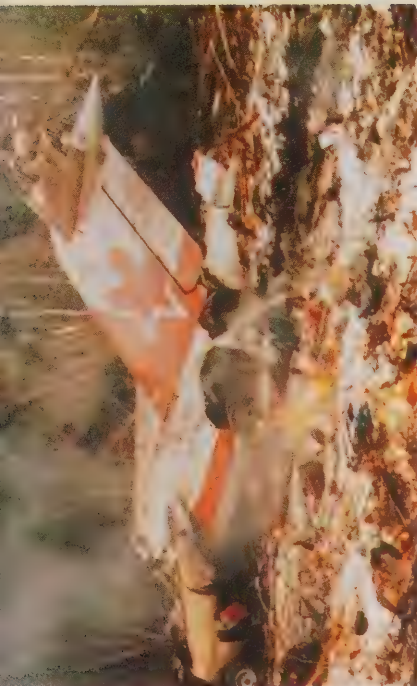
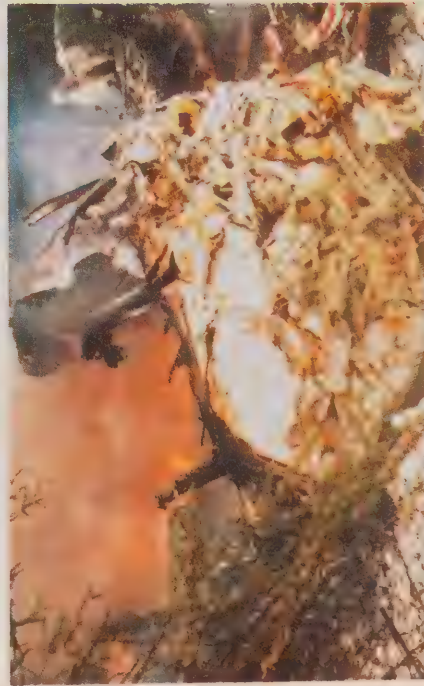
These photographs, taken by one of the fire-fighters in mid-afternoon March 10, 1989, convey the intensity of the fire which, by this time, is nearly extinguished.

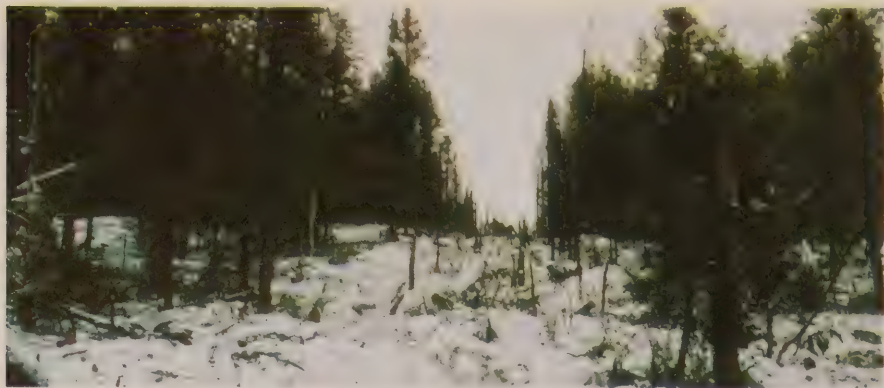
The wreckage trail looking east from the site of the crash

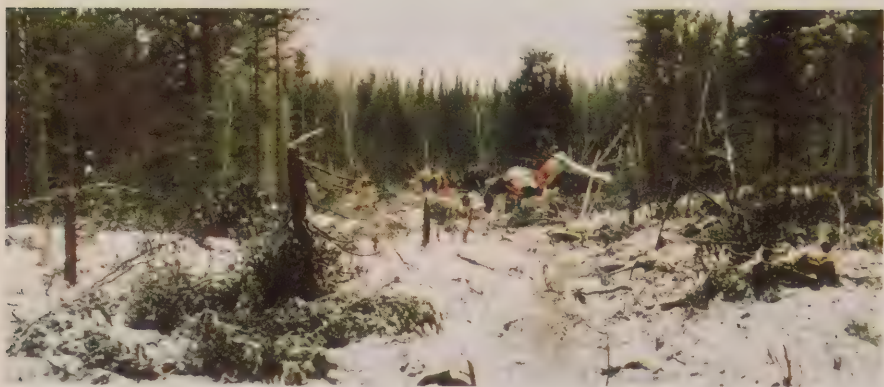
The wreckage trail looking west towards the wreckage from part way along the trail

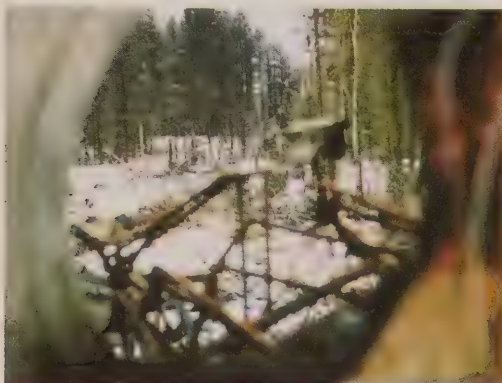
The wreckage trail shot through the fuselage of the aircraft

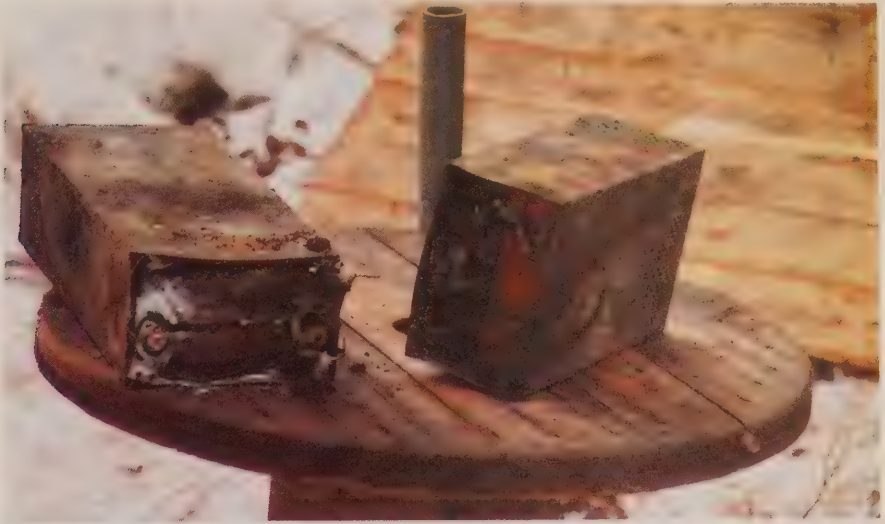
The cockpit voice recorder and flight data recorder were recovered, buried in debris, approximately 24 hours after the crash. On disassembly, it was discovered that the recording medium of both recorders had been destroyed by severe heat damage.

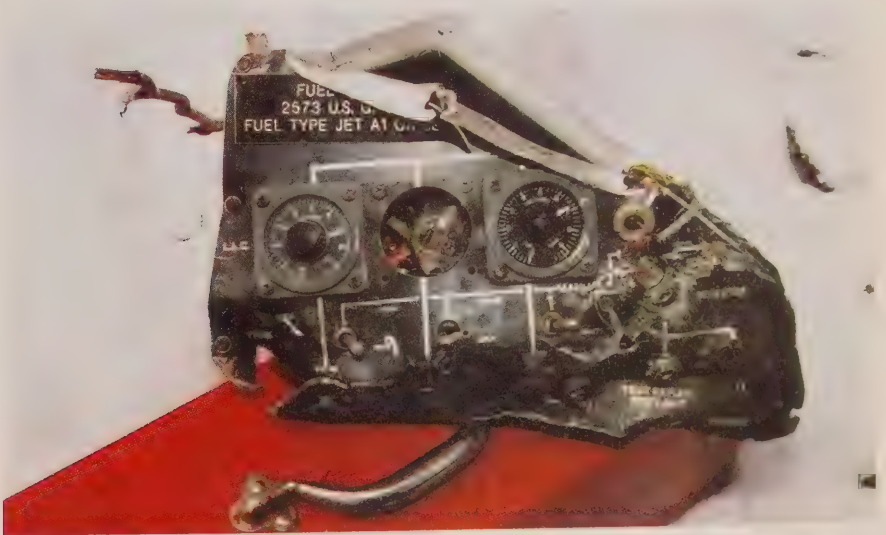
The refuelling panel, located in the wing, shows a fuel load of approximately 14,000 lbs.

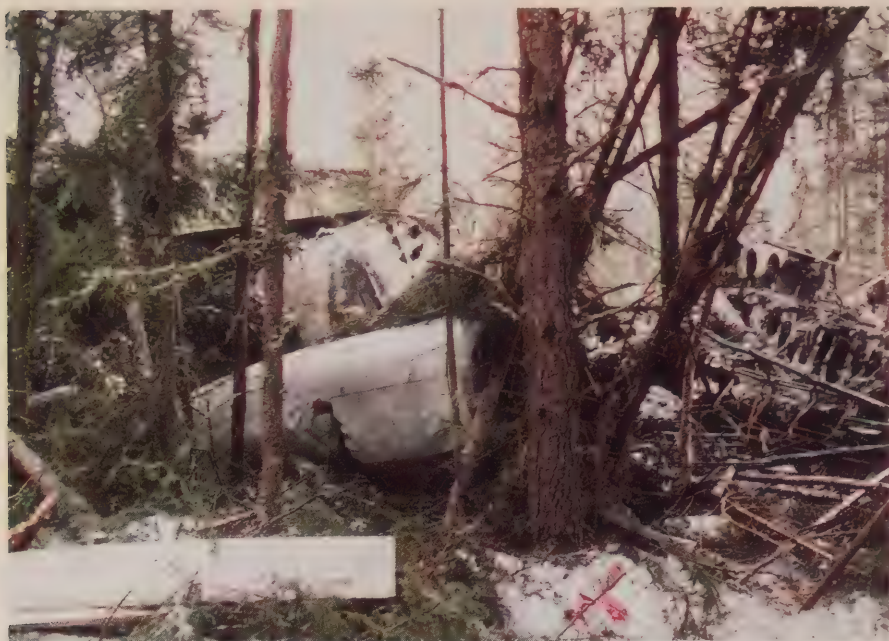
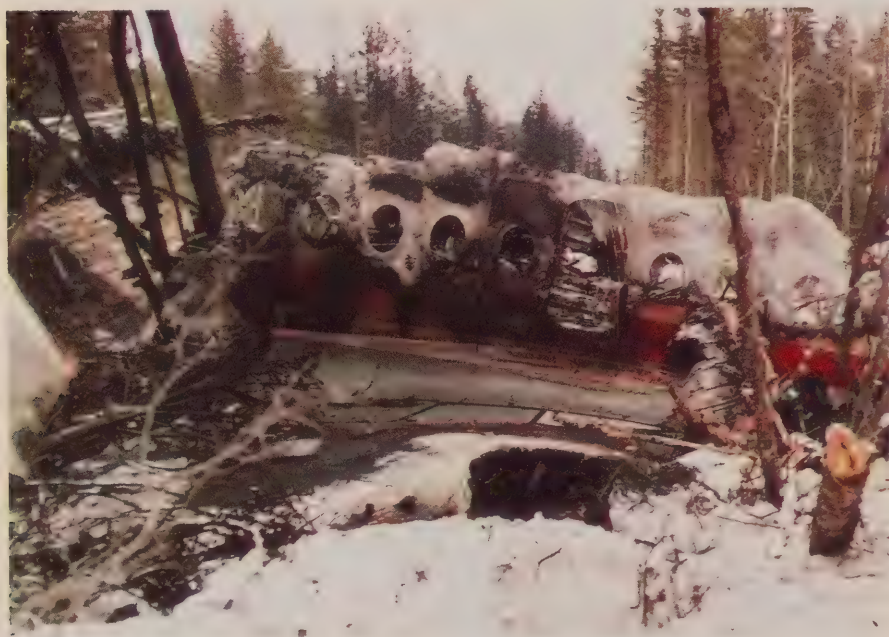
The wreckage was carefully photographed in situ at the crash site by the investigators: top, right engine; bottom, rear section of the right side of the fuselage.
